# **Reconstruction of the Zagreb Cathedral**

**Croatia**

# Damages in the 2020 earthquake

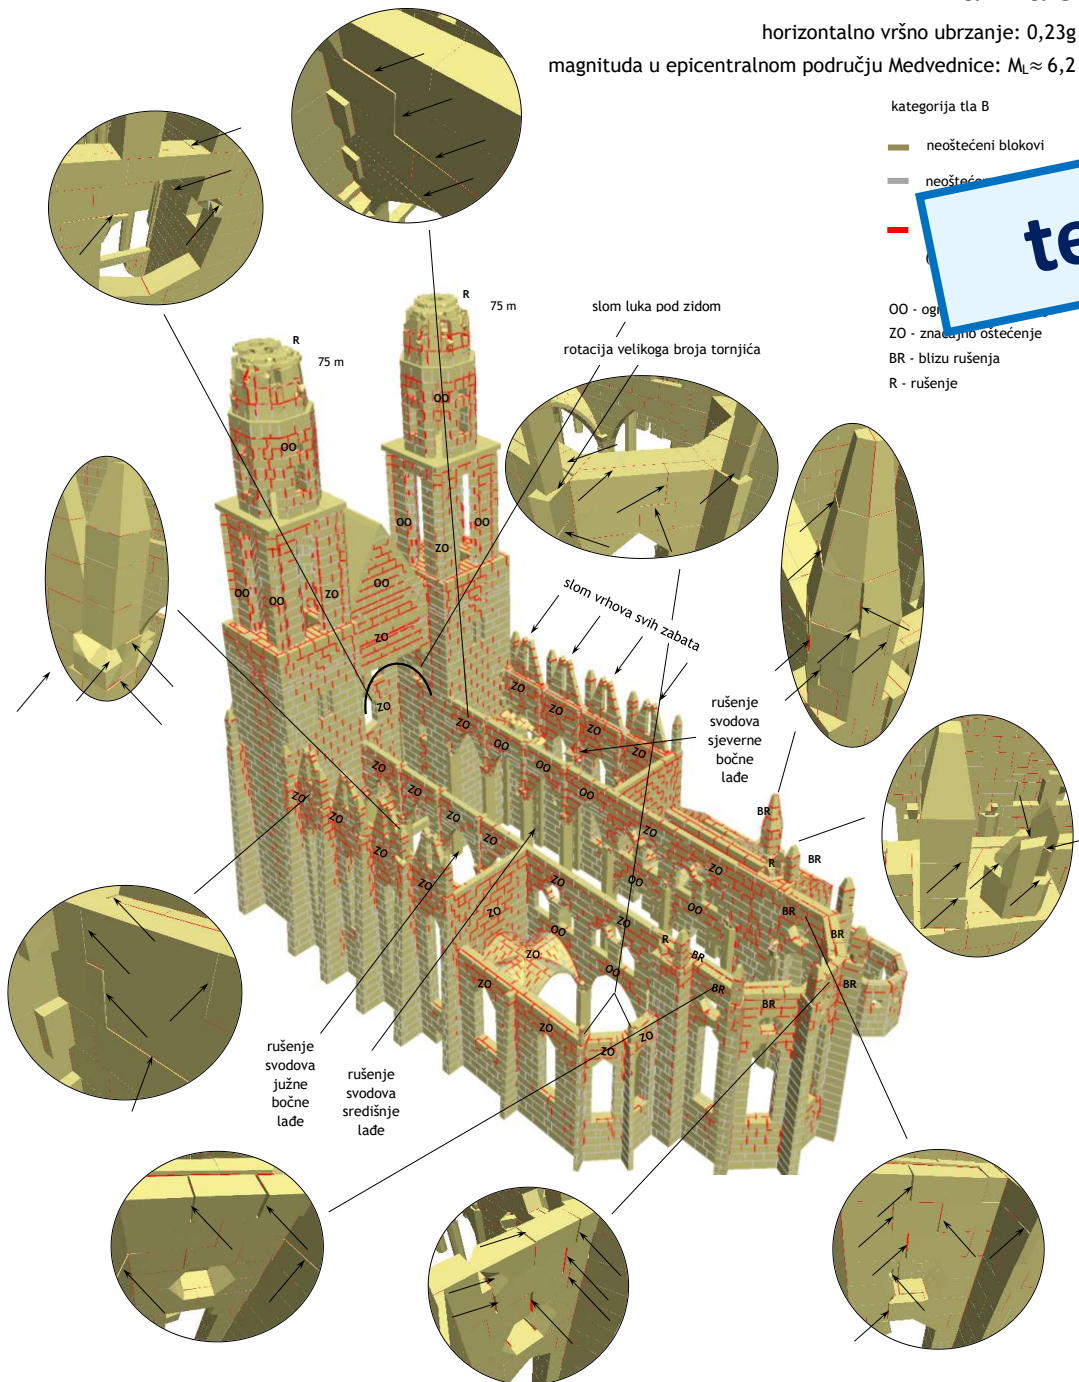
## Razina 3

horizontalno vršno ubrzanje: 0,23g  
magnituda u epicentralnom području Medvednice:  $M_L \approx 6,2$

kategorija tla B

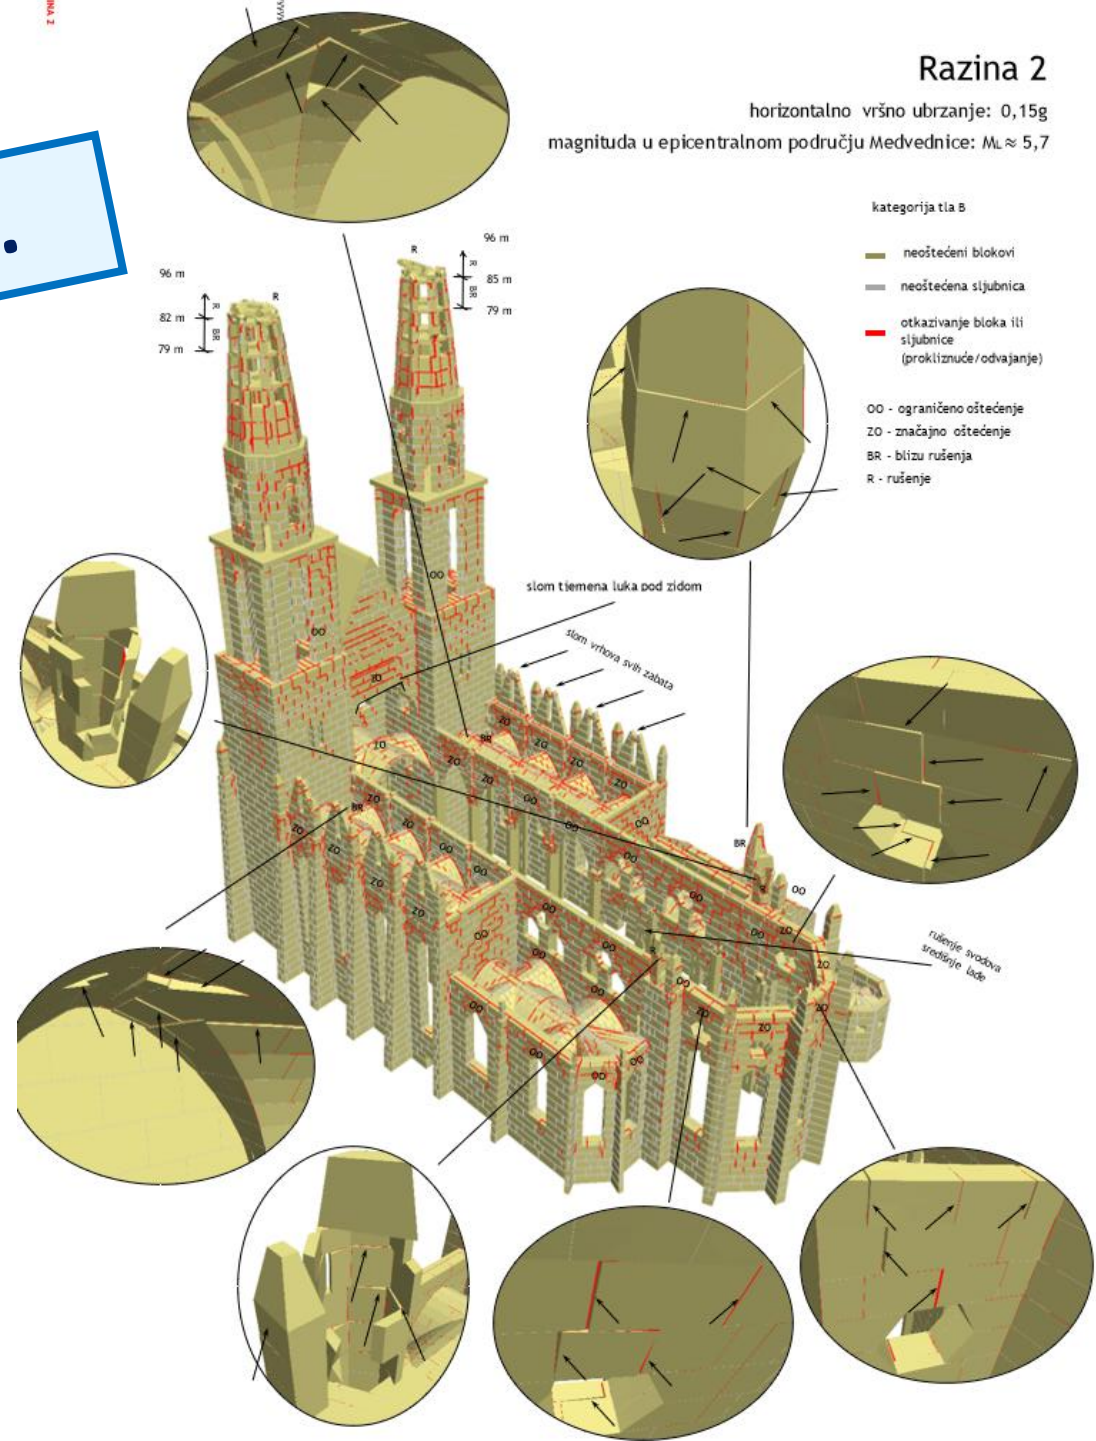
## Razina 2

horizontalno vršno ubrzanje: 0,15g  
magnituda u epicentralnom području Medvednice:  $M_L \approx 5,7$

kategorija tla B
