# **Reconstruction of the Zagreb Cathedral**

**Croatia**

# Damages in the 2020 earthquake

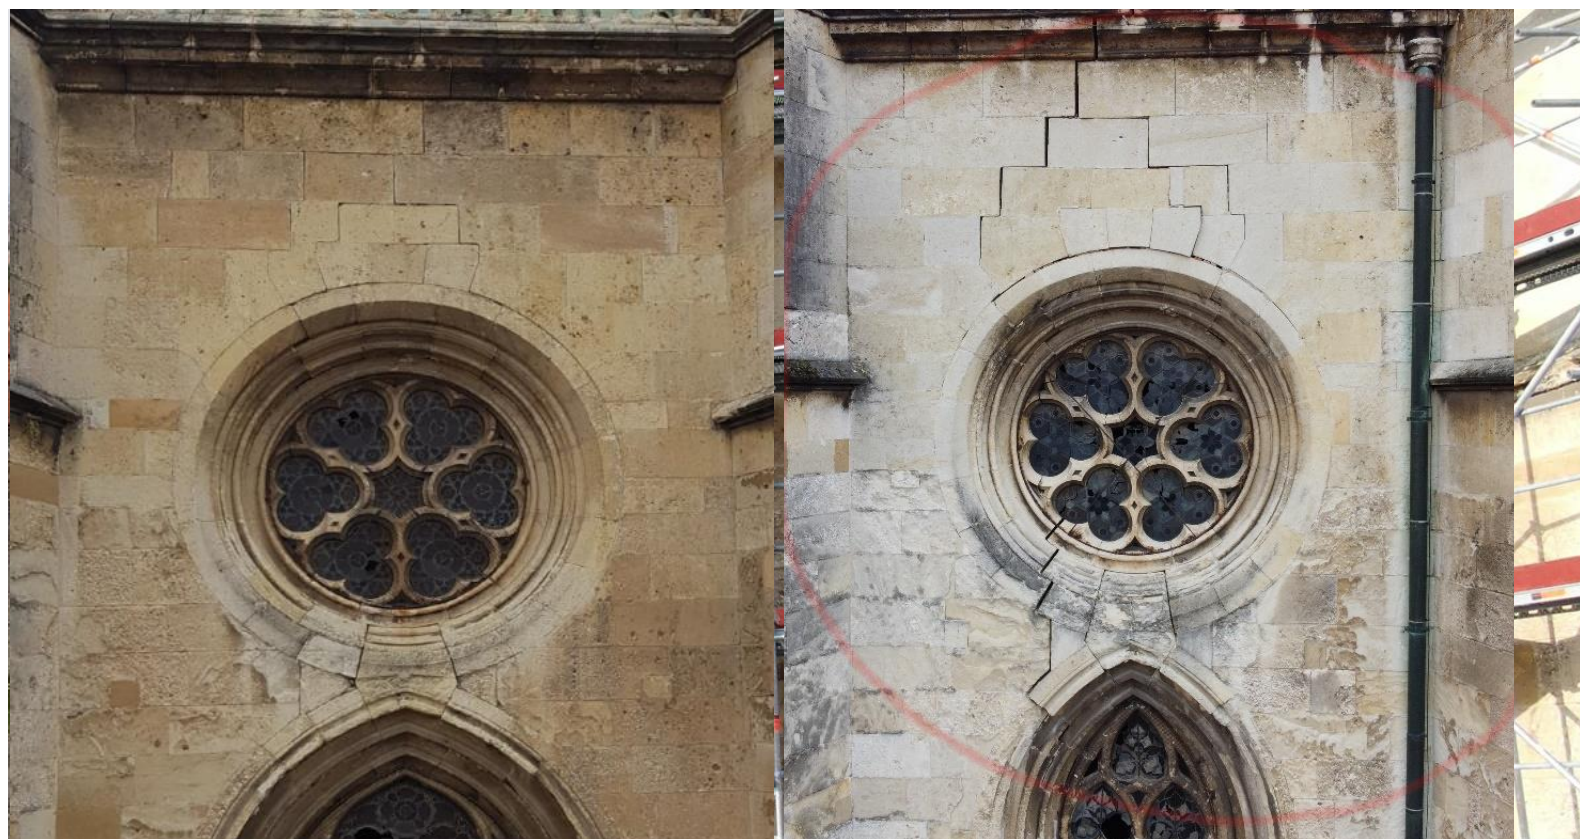
After Petrinja 2020 earthquake

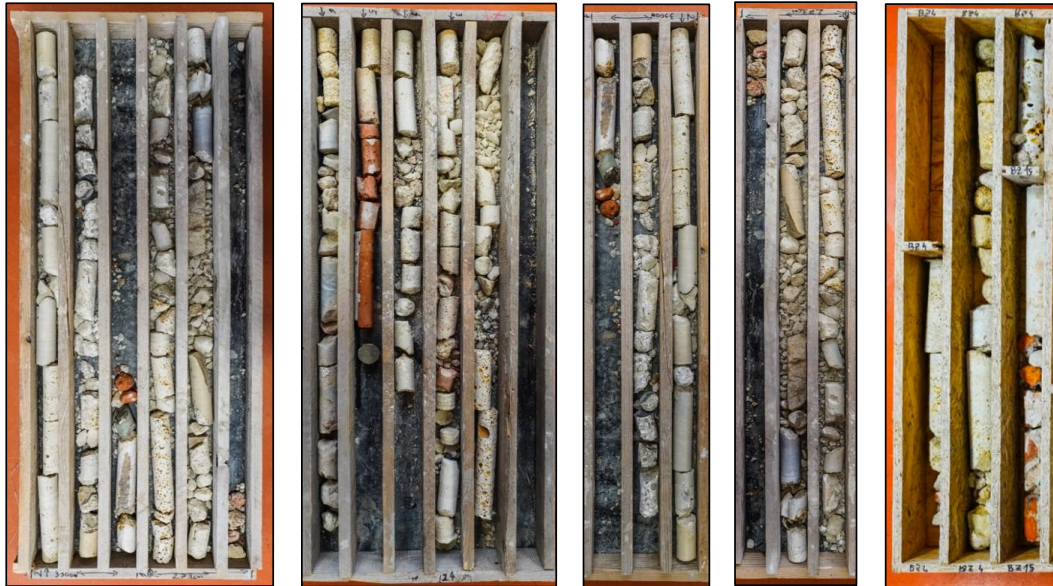
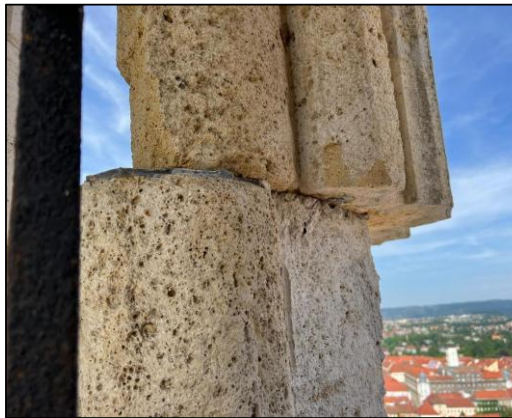
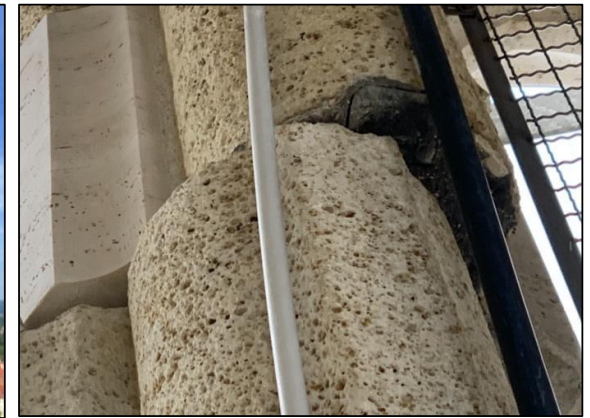
- Visible and hidden **cracks**
- Very **discontinuous** material without reinforcement, extremely loose in some places
- During an earthquake, wall elements separate, twist, slide and crack
- The **displacements and angles of rotation** of the modal nodes are not connected
- Natural **anisotropy** of stone
